RED RIVER WATERSHED

GILLHAM LAKE

COSSATOT RIVER, ARKANSAS

EMBANKMENT CRITERIA AND PERFORMANCE REPORT

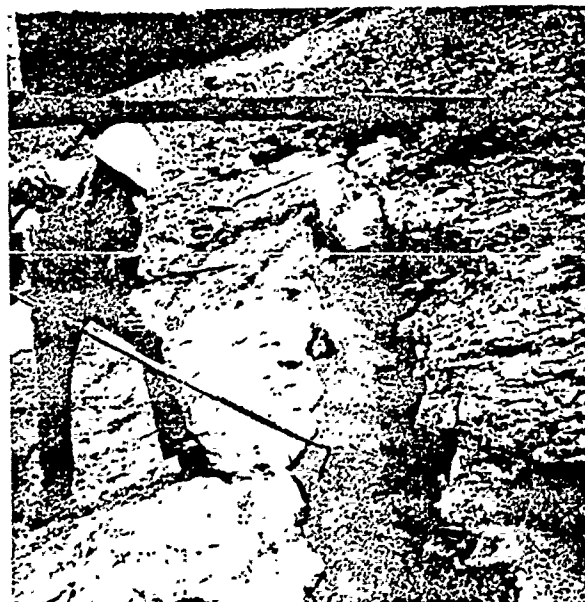
Photo. No. 25

Open fracture at Sta 25+30 being
backfilled with concrete.

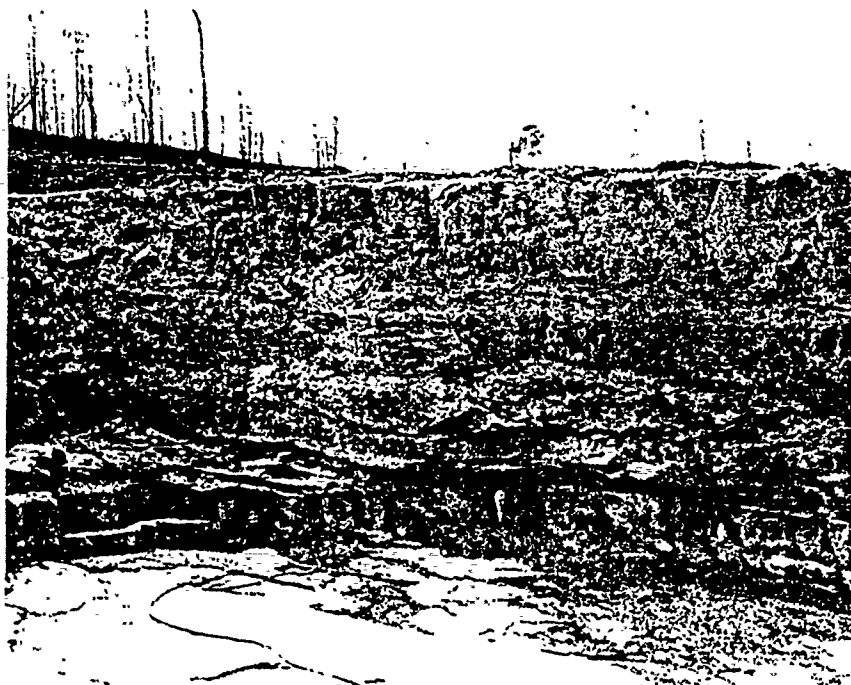
Photo. No. 26

D/S half of the step face at Sta 25+80± prior to placing concrete to eliminate the overhang.

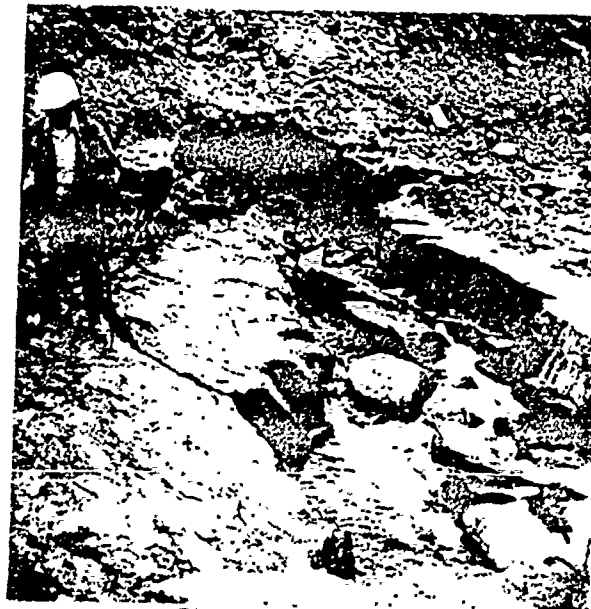
Photo. No. 33

This view (looking U/S from centerline) of the fracture at Sta 26+40 to 26+60 shows partial filling with grout at the lower right. This area was backfilled with concrete.

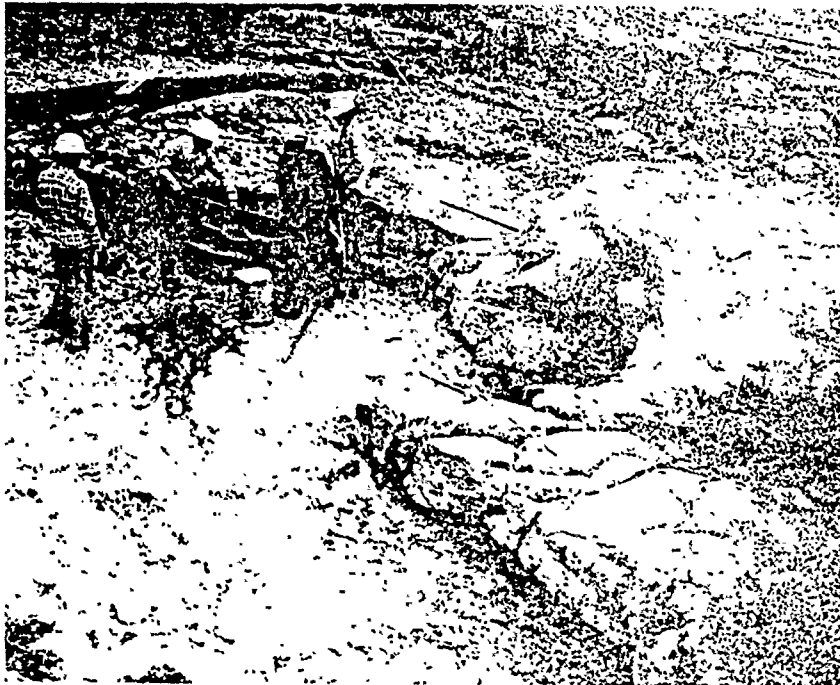
Photo. No. 38

- B-19 Photo No. 38. Sand grout is being mixed by hand to backfill a small crack extending D/S from the previously concreted area at 26+50(+/-). The concrete plug lies under the broom at the right edge of the photo.

Sand grout is being mixed by hand to back up the area of the existing D/S from the previously concreted area at 1-7-1. The broom lies under the broom at the right edge of the area.
